## 1934 THROUGH 1947

## 1948 THROUGH 1953

## 1954 THROUGH 1961

## HYDRANT WITH SEALED OIL RESERVOIR - 1962 STYLE

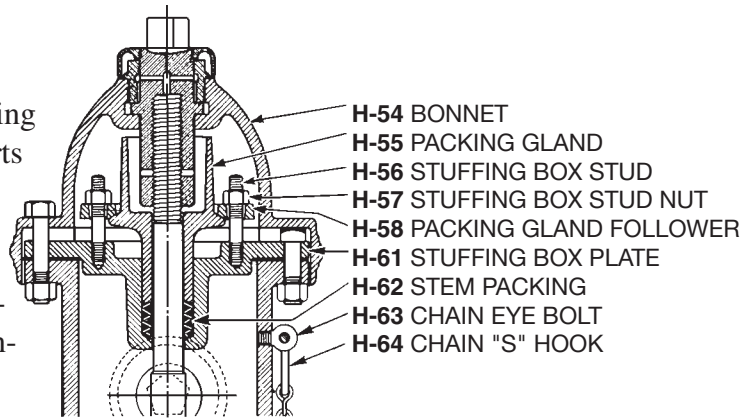
Bonnet section of hydrant with conventional packing and without oil filler plug in bonnet. All other parts same as on previous page.

Appearance same a 1948 through 1953. No filler plug. If nozzle chains are attached to eyebolt, bonnet is the style, unless changed. Packing in conventional.

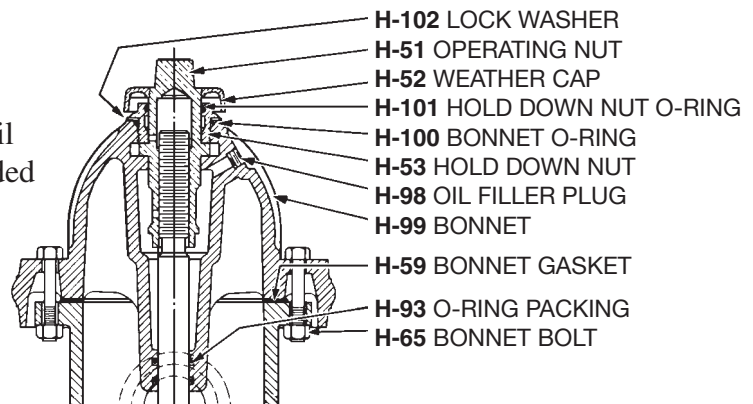
Hydrant bonnet is marked SR on top of flange. Oil filler plug is set on an angle. Lock washer was added in 1965. Year date is marked on side of barrel.
