# Mueller® Post Indicator Replacement

## A20801 TO A20806 CONVERSION INSTRUCTIONS

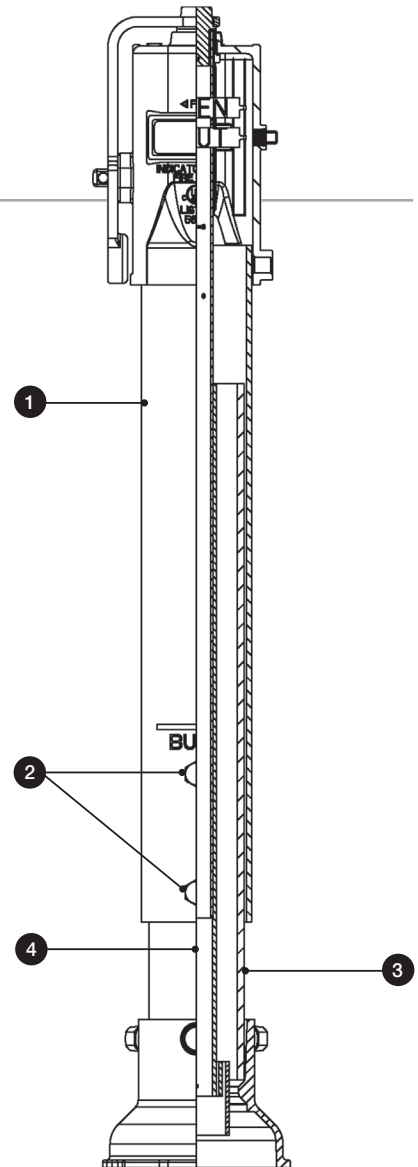
ID	PART NAME
1	Upper Barrel
2	Hex Head Screw
3	Lower Barrel
4	Lower Stem

1. Dig down around the A20801 Post Indicator until the bottom of the Upper Barrel (no. 1) can be seen.
2. Loosen the 2 Hex Head Screws (no. 2) so that the Upper Barrel is free.
3. Separate the Upper Barrel from the Lower Barrel (no. 3) and set aside.

1. Determine the correct A20806 "Order Length". Consult Mueller Catalog Section E-1-2 for assistance.
2. Remove the Lower Barrel (no. 3) from the New A20806 Post Indicator.
3. Remove the telescoping Lower Stem (no. 4) from the New A20806 Post Indicator.
4. Lower the new A20806 Lower Stem into the existing A20801 Lower Barrel.
5. Align the Lower Stem Coupling and seat on the Valve Wrench Nut.

6. Place the A20806 Upper Barrel Assembly on the existing A20801 Lower Barrel.
  7. Tighten the 2 Hex Head Screws (no. 2).
- Adjust the targets (if necessary). Follow instruction in A20806 Operation Manual.
